***In-situ* Corrosion Studies on Wrecked Aircraft of the Imperial Japanese Navy in Chuuk Lagoon, Federated States of Micronesia**

Ian D. MacLeod

Western Australian Museum Collections and Research Centre, Kew Street, Welshpool, Western Australia 6106

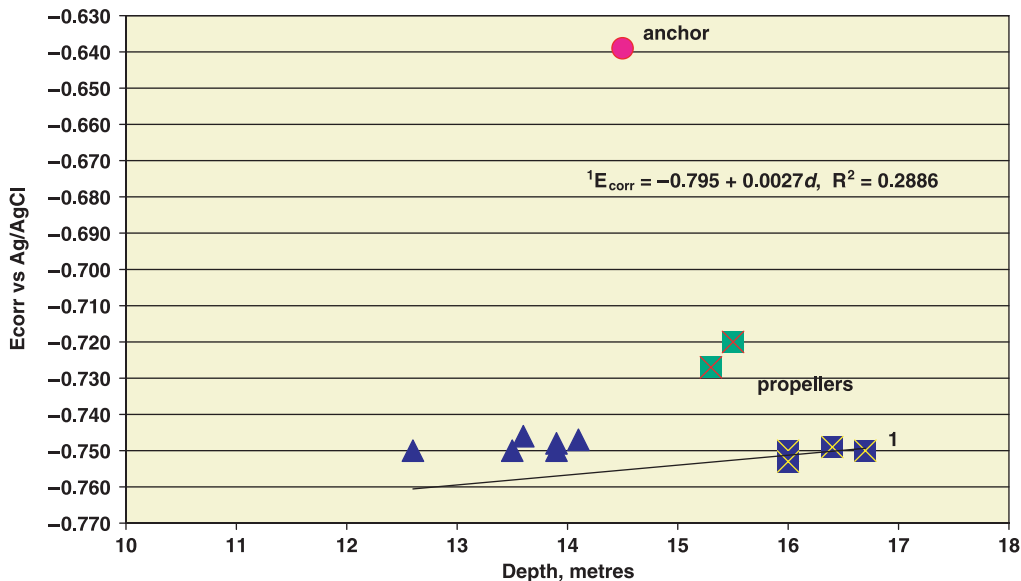
Figure 2. Plot of E_{corr} for the aluminium alloys on the *Emily* flying-boat as a function of water-depth.

Since aluminium alloys have widely different values it is important to group the data according to alloy functionality when reviewing the impact of parameters such as water-depth. The values for the 'Duralumin' type of skin-sheeting from the starboard wing, wing-float, fuselage and lightweight frame showed an anodic shift of 2.7 millivolts per metre of increasing depth but the scatter of the data (Fig. 2) gave an R^2 of only 0.2886. A similar slope was observed for the E_{corr} data from the cowling, cockpit and engine nacelle

but more measurements are needed to improve the quality of data from this site.

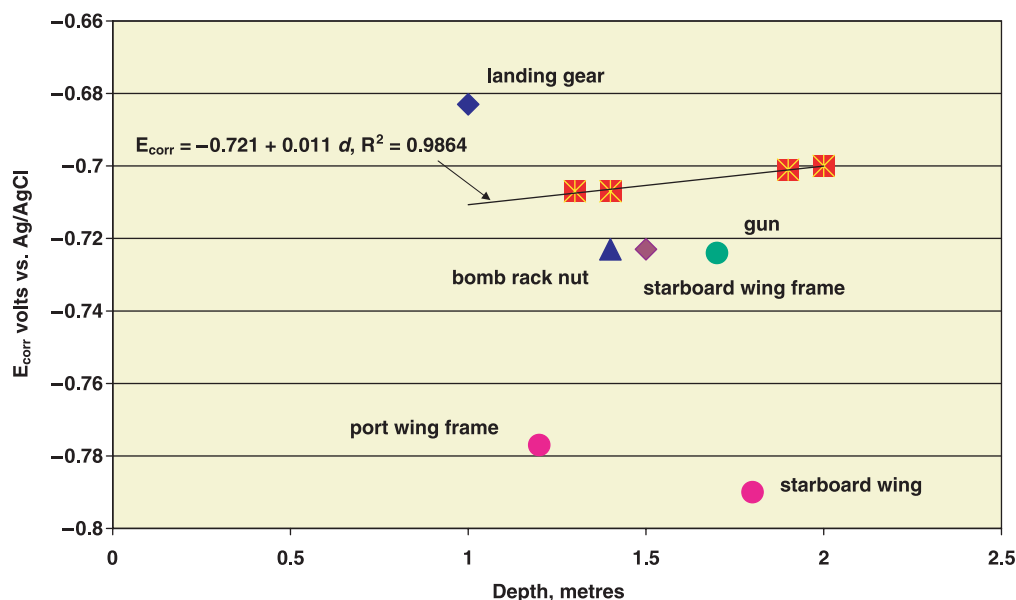
Figure 3. Corrosion potentials of the *Zeke* fighter plane off Eten Island.

Narayan, 1989). The difference of 77 mV in the corrosion-potentials on two sections of the port wing is probably a reflection of the different alloys that were used in its construction (Table 2). Most of the E_{corr} values fall into either that with a mean of -0.704 ± 0.004 V and the other at -0.723 ± 0.002 volts. When the E_{corr} data is plotted as a function of water-depth (Fig. 3) the linear regression had an R^2 value of 0.9864 and it gave equation 3

$$\text{Eten Zeke } E_{\text{corr}} = -0.721 + 0.011 d \quad (3)$$

where d is the water-depth in metres. The intercept error was ± 2 mV and the slope had an error of ± 0.0009 volts per metre. The apparently greater sensitivity of E_{corr} on water-depth than observed on the *Emily* (14.4 ± 1.4 m) and *Judy* dive-bomber (2.5 ± 0.4 m) is not surprising as the *Eten Zeke* site (1.5 ± 0.3 m) will have strong surface mixing. Since the gun pH at 8.22 is more alkaline than the surrounding sea-water at pH 8.12 and is much more alkaline than the mean pH of 7.74 ± 0.05 for the rest of the wreck indicates that it is being cathodically protected by corroding aluminium alloys. The E_{corr} of the landing-gear reflects the differences in composition between cast-aluminium alloys and wrought and extruded alloys on other parts of the wreck.

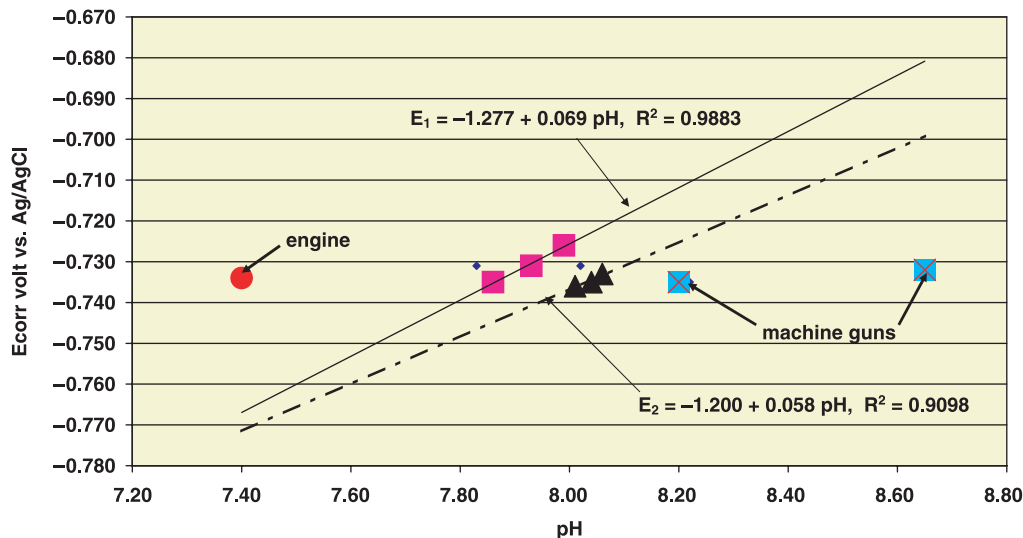
Figure 4. Plot of pH versus E_{corr} for the upside-down *Zero* off Eten Island.

wings into two pieces. The mean E_{corr} was -0.733 ± 0.003 V, which is nearly 30 mV more negative than the *Eten Zeke* (Table 1). The pH values of 8.20 and 8.65 for the two guns indicate that the surrounding aluminium alloys are actively protecting them. Its general micro-environment is best seen in a Pourbaix plot (Fig. 4) where the E_{corr} values are plotted against the pH of the objects. The two machine-guns and the concreted spot on the engine have atypical pH to other parts of the site that indicate a clear connectivity between E_{corr} and pH. Two sub-sets of data have a common slope of $+64 \pm 8$ millivolts which indicates that one proton is involved with each electron. The corresponding equations are

The difference of 77 millivolts in the intercepts is due to compositional differences in the aircraft skin and frames since addition of an extra 2% copper in solid solution with aluminium results in a 60 mV difference in E_{corr} of the wrought alloys (Table 2). Despite the difficulties in gaining accurate pH data on submerged aircraft wrecks in Chuuk the variation in pH with E_{corr} for the *upside-down Zero* provides an insight into the

corrosion mechanism. Thermodynamic data on aluminium complex ions shows that $\text{Al}(\text{OH})_3$ is the dominant form at pH values above 7 at room temperatures, $\text{Al}(\text{OH})_2^-$ in the range 7–6 and $\text{Al}(\text{OH})^{2+}$ between 6–5.5 (Lowson, 1974). The gelatinous nature of the corrosion-products on the aluminium alloys is consistent with them being aluminium hydroxide gels mixed with algae.

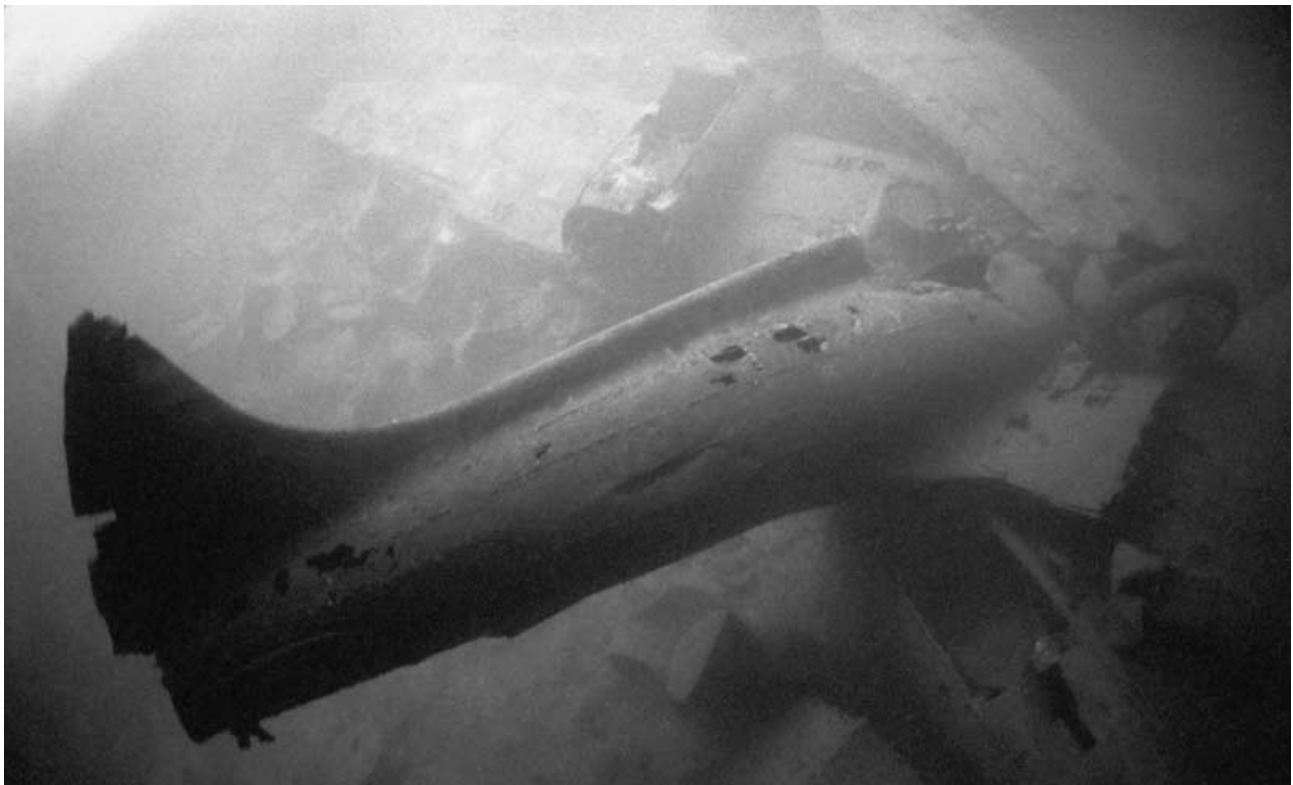
Diving conditions limited measurements inside the forward hold of the *Fujikawa Maru* to three aeroplanes. Subsequent historical analysis (Jeffery, 2004) showed that one of the planes was a Mitsubishi A5M (Type 96 Carrier Fighter) to which the USA gave the code-name *Claude*, the world's first mono-wing shipboard fighter (Fig. 5). The two *Zeros* had a mean E_{corr} of -0.747 ± 0.006 volts while the *Claude* was -0.710 volts and there was no real difference in the pH values which had a mean of 7.63 ± 0.02 (Table 1). The aircraft are clearly electrically isolated from the steel in the hold for otherwise they would have been selectively corroded to protect the surrounding iron ship. A Japanese aircraft-production worker

reported that a layer of pure aluminium was bonded on the surface of the Duralumin type of alloys to improve the corrosion-performance of the alloys in the latter part of the war during which the two *Zeros* were made (pers. comm. Chiaki Ajioka, 2004).

Figure 5. Inside the hull of the *Fujikawa Maru* with the *Claude* in the foreground and one of the *Zeros* behind with the painted numerals '39' on the highlighted section. (Bill Jeffery)
